### AIRBORNE SOUND TRANSMISSION LOSS

ASTM E 90

<b>Test Date</b>	05/05/16						
<b>Data File No.</b>	F8388.01B						
<b>Client</b>	Dual Action Windows, LLC						
<b>Description</b>	Series/Model: DAW Alu72, Side Entry Door, with 1-13/16" IG(1/2" laminated exterior, 1" air space, 5/16" laminated interior) Glass temperature 75°F						
<b>Specimen Area</b>	2.22 m <sup>2</sup>	Receive Temp.	22.2 °C		Source Temp.	21.3 °C	
<b>Technician</b>	Leeland S. Hoov	Receive Humidity	51%		Source Humidity	53%

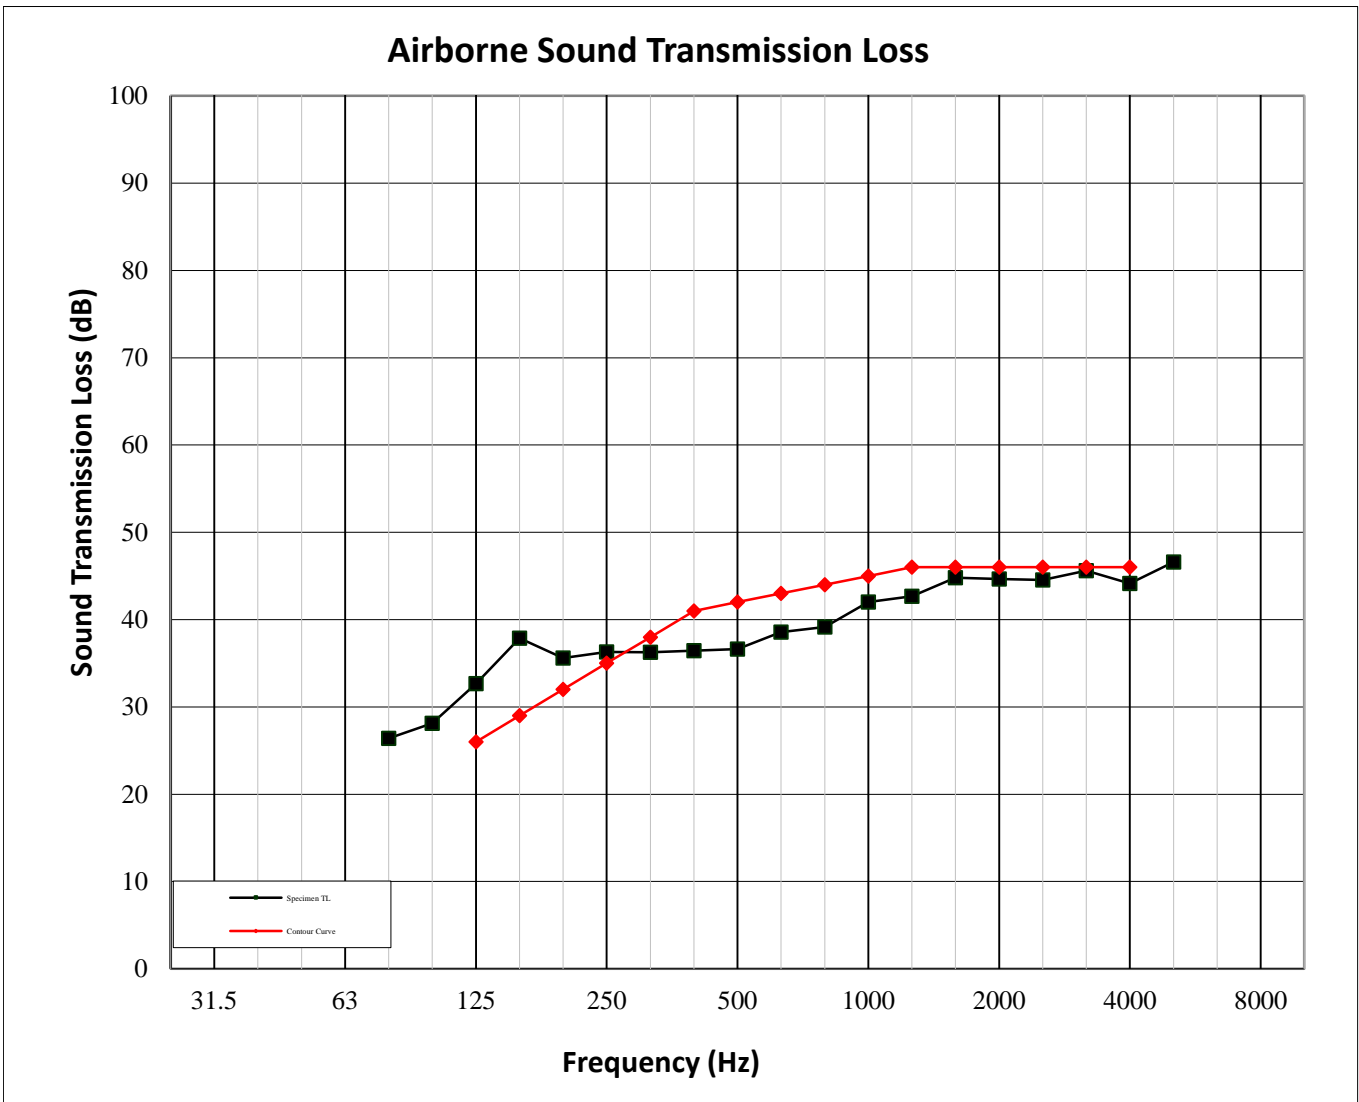
**AIRBORNE SOUND TRANSMISSION LOSS**  
ASTM E 90

<b>Test Date</b>	05/05/16					
<b>Data File No.</b>	F8388.01B					
<b>Client</b>	Dual Action Windowss, LLC					
<b>Description</b>	Series/Model: DAW Alu72, Side Entry Door, with 1-13/16" IG(1/2" laminated exterior, 1" air space, 5/16" laminated interior) Glass temperature 75°F					
<b>Specimen Area</b>	2.22 m <sup>2</sup>	Receive Temp.	22.2 °C		Source Temp.	21.3 °C
<b>Technician</b>	Leeland S. Hoov	Receive Humidity	51%		Source Humidity	53%

Freq (Hz)	Background SPL (dB)	Absorption (m <sup>2</sup> )	Source SPL (dB)	Receive SPL (dB)	Specimen TL (dB)	95% Confidence Limit	Number of Deficiencies
80	36.6	5.1	97	68	26.4	1.93	-
100	35.8	5.7	99	68	28.1	1.95	-
125	37.3	5.0	100	65	32.7	1.41	0
160	40.3	4.6	99	60	37.9	1.23	0
200	38.7	4.5	101	62	35.6	0.64	0
250	34.7	5.1	100	60	36.3	0.69	0
315	27.9	5.3	94	54	36.3	0.50	2
400	24.5	5.6	91	50	36.4	0.23	5
500	21.1	5.8	90	49	36.6	0.44	5
630	19.4	5.6	94	52	38.6	0.42	4
800	17.7	5.8	94	51	39.2	0.32	5
1000	12.6	6.0	92	45	42.0	0.19	3
1250	10.9	6.6	93	46	42.7	0.23	3
1600	8.1	6.9	94	44	44.8	0.26	1
2000	7.1	7.4	89	39	44.7	0.29	1
2500	5.5	8.4	86	36	44.6	0.27	1
3150	5.3	10.0	86	34	45.6	0.36	0
4000	6.0	12.2	85	33	44.1	0.49	2
5000	7.0	15.6	84	29	46.6	0.79	-

**STC Rating**            **42**            *(Sound Transmission Class)*  
**Deficiencies**        **32**            *(Sum of Deficiencies)*  
**OITC Rating**        **37**            *(Outdoor-Indoor Transmission Class)*
